SUBARU

**WARRANTY BULLETIN**

APPLICABILITY: Impreza STi
SUBJECT: Axle Shaft Breakage and/or Damage
from Abuse

NUMBER: 01-159-05
DATE: 01-18-05

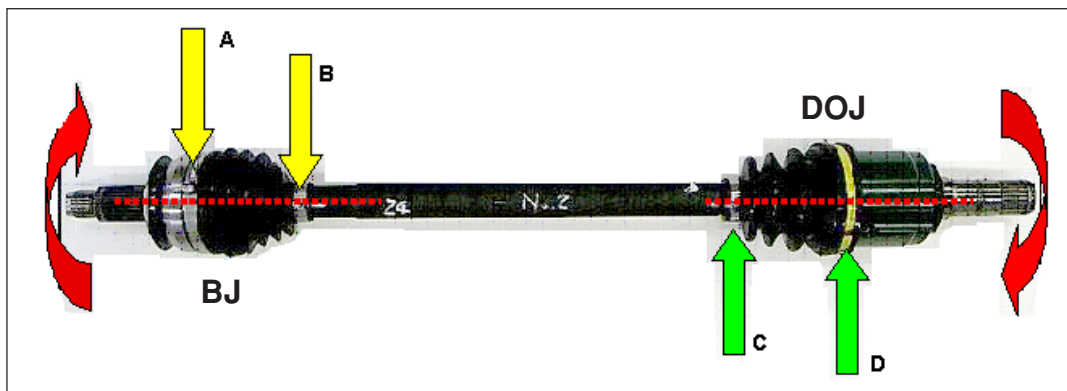
Figure 1

If an extreme load is placed on rear axle shafts, one side could break and the opposite end could twist, both sides could twist or both sides could break. To inspect for a twisted axle shaft, inspect the crimp location on the axle boot bands. They should be aligned in a longitudinal direction as illustrated by the red dots (*see Figure 1*). However, this may not be necessarily true if the axle boots and/or bands have been replaced previously. It is recommended that you check prior repair history before concluding that misalignment is evidence of abuse. The example shows that the "Bell Joint" (BJ) side and the "Double Offset Joint" (DOJ) side are twisted. The bands on the BJ, A & B, should be aligned with each other. The bands on the DOJ, C & D, should be aligned with each other. However, the bands on the BJ do not necessarily have to be inline with the bands on the DOJ.

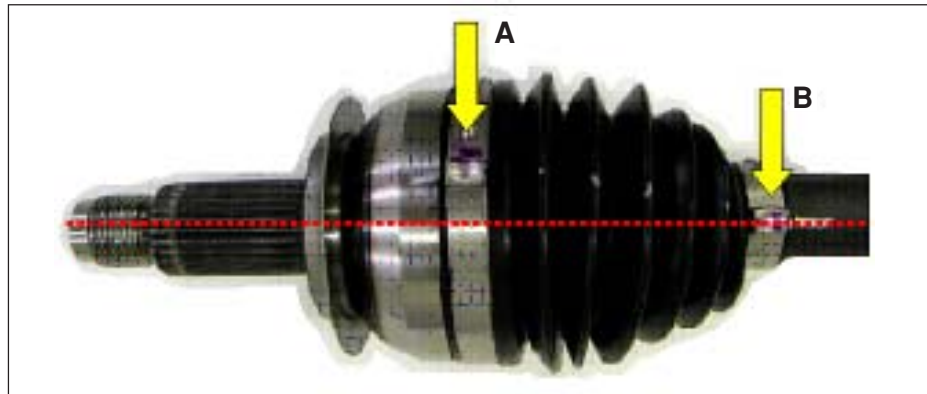
Figure 2

BJ (wheel side) axle was twisted; A & B are not aligned (see *Figure 2*).

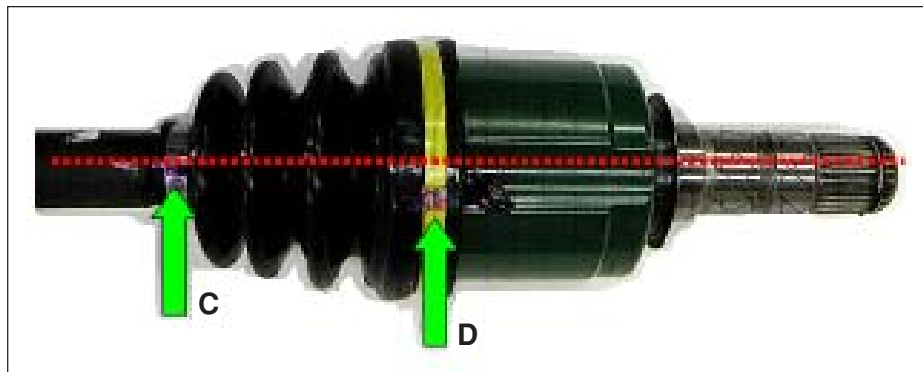
Figure 3

DOJ (rear differential side) axle was twisted; C & D are not aligned (see *Figure 3*).

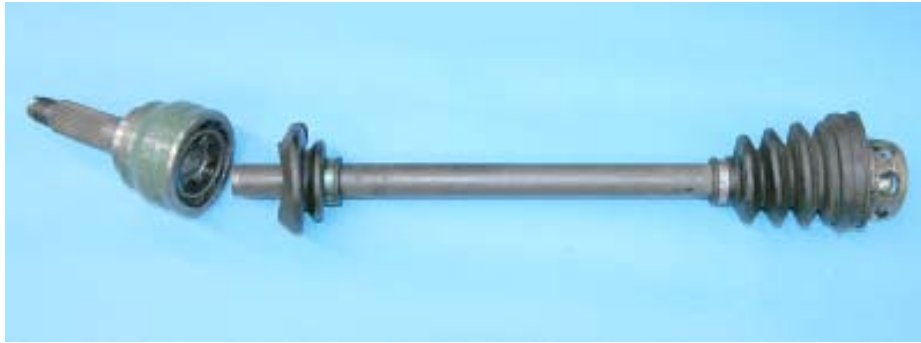
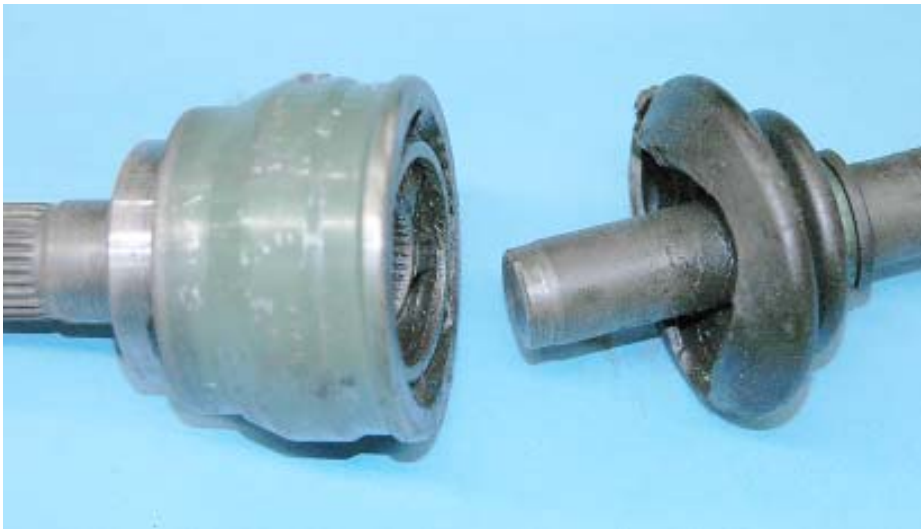
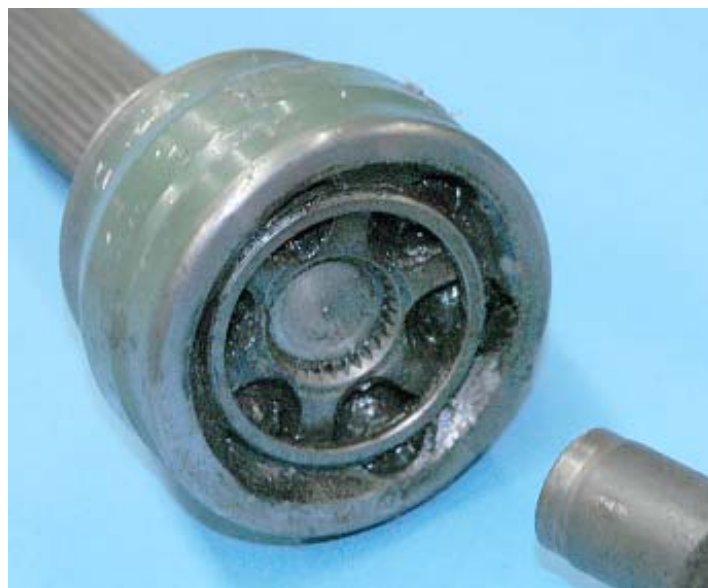
The following 3 photos (*Figures 4, 5, and 6*) show an axle shaft that was sheared off at the “Bell Joint” (BJ) as the result of abuse.
